Expert Home Inspections

PROPERTY INSPECTION REPORT

Concerning: 606 W Nash Street, Terrell, TX 75160
(Address or Other Identification of Inspected Property)

By: Mark Serrioz, Lic #20867 07/10/2020
(Name and License Number of Inspector) (Date)

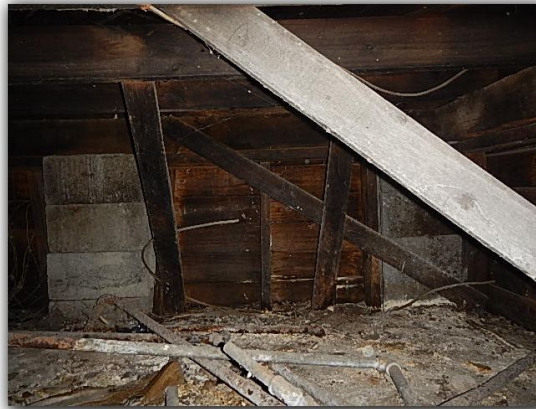
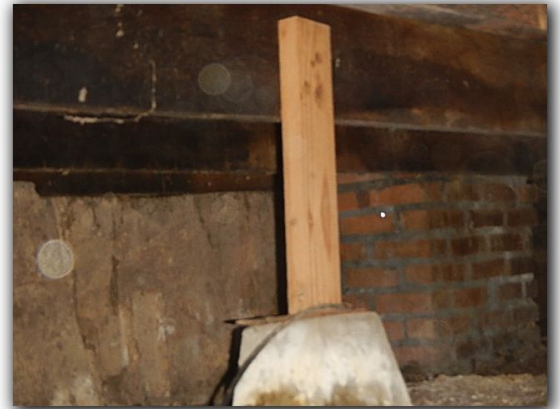
- The following movement indicators were observed indicating that some degree of foundation settlement has occurred. Some degree of foundation settlement is normal for every home. The degree or seriousness of settlement cannot be determined at a one time general home inspection. If there are any further concerns, an evaluation by a structural engineer is recommended. Doors binding, Sloping floors
- Vantage point from where the crawl space was viewed: Portions were crawled, some areas inaccessible

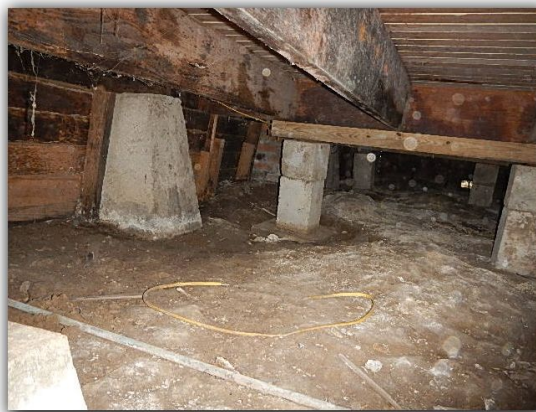
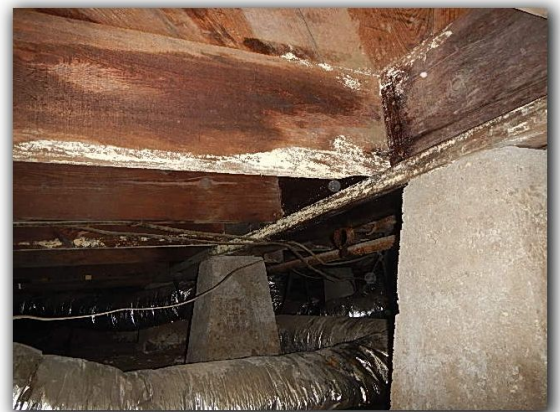
- A 1X6 is being used as a pier support. Cement or 4x4 is recommended.

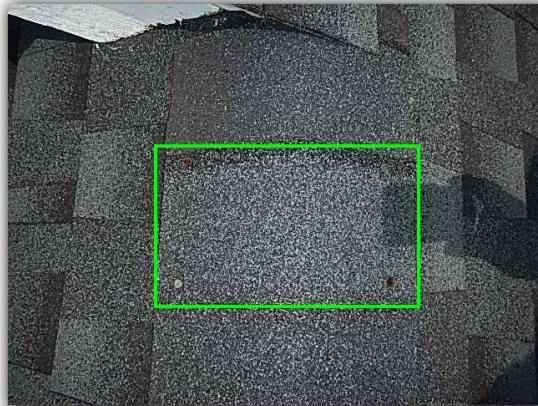
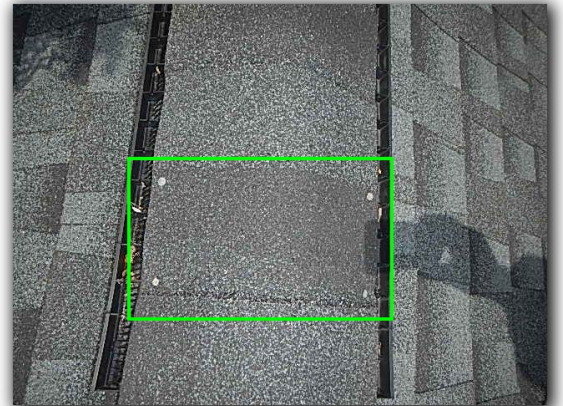
- Exposed nail heads were observed on the roof shingles. All exposed nail heads should be sealed with roofing caulk or sealant.

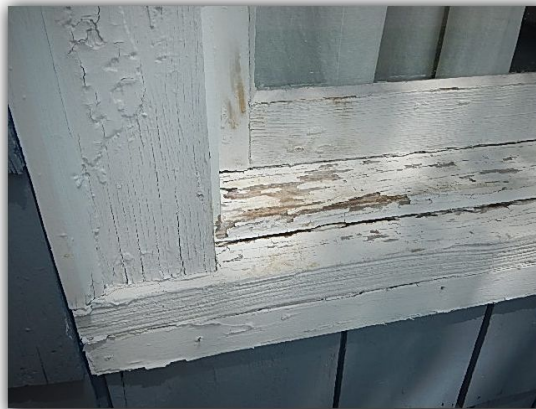
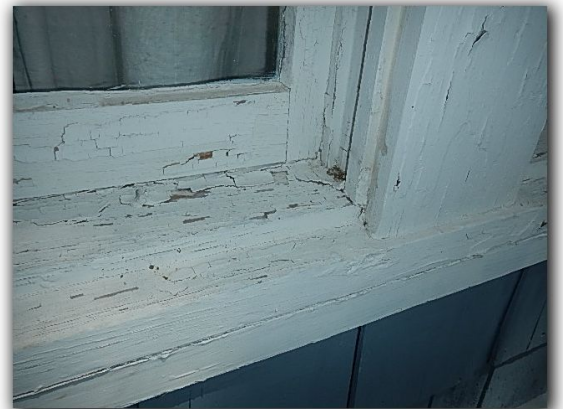
- Paint or water resistant materials and coatings are needed to protect wood from water damage in the following location(s) exterior siding, exterior window trim, exterior door trim, rear door , facia boards, Exterior trim

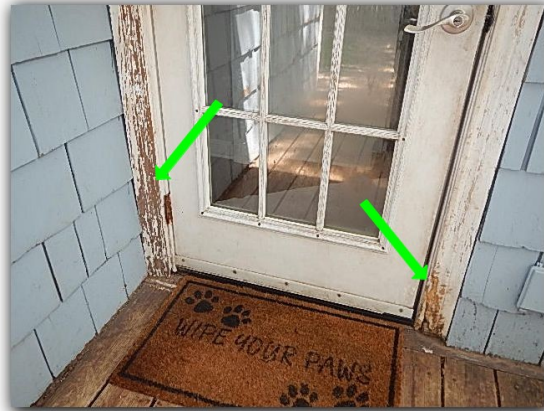
- Paint is needed to protect wood from water damage in the following location(s) rear door

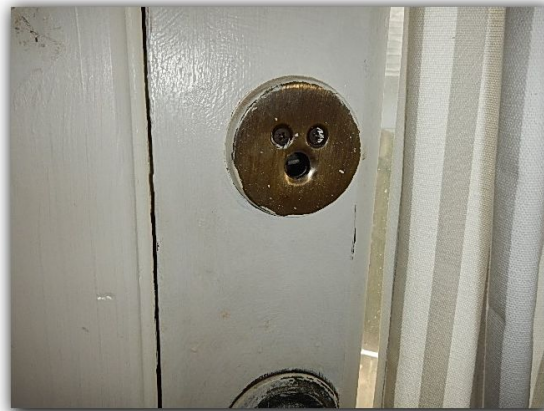
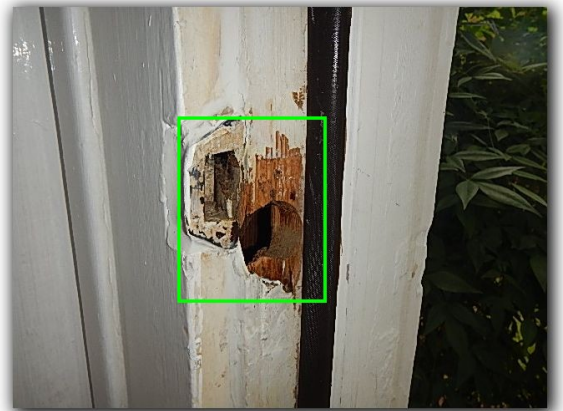
- Damaged or non-functional door hardware should be repaired.

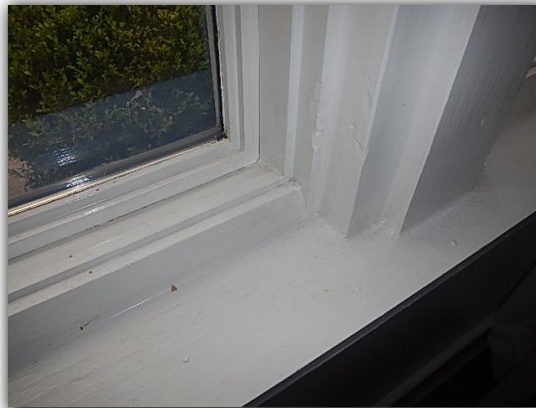
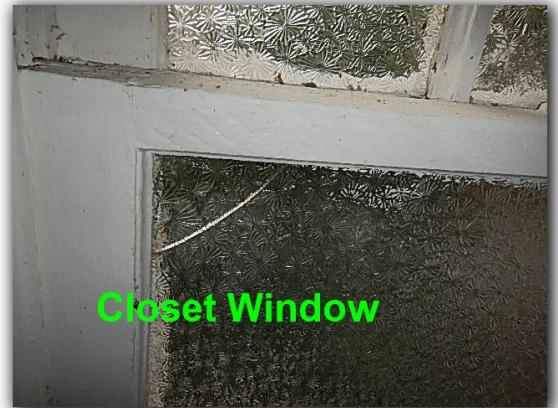
- The window(s) are painted shut. Improvement should be undertaken to allow normal operation of the window. All windows should be operative for quick egress in the event of a fire.
- Broken and or cracked window(s) were observed. Repair is recommended.

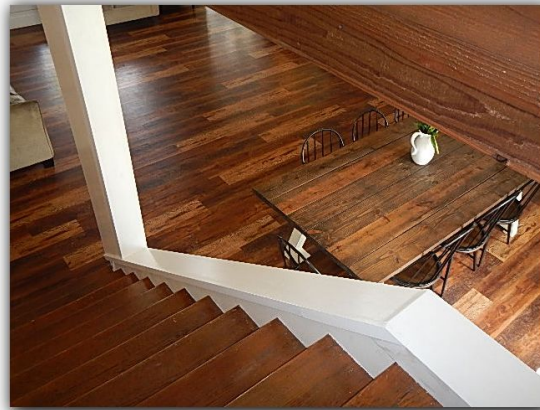
- The stairs should have a rail on both sides.

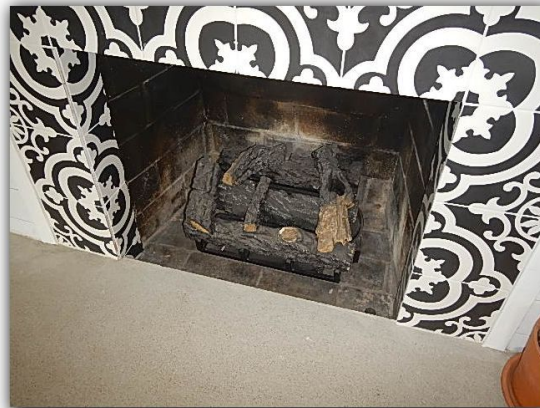
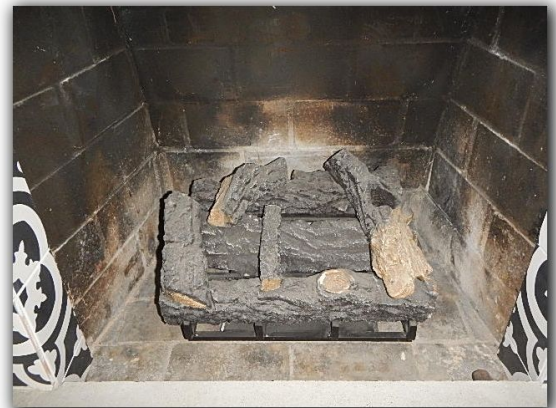
- The fire place is missing or has a damaged spark screen. Spark screens can keep sparks and or logs from coming out of the fireplace. They also may keep a child from falling into the fireplace. A fixed or attached spark screen should be in place. This is recognized as a safety hazard.
- It appears that gas logs are in place but the gas is not connected. All gas fired appliances should be vented to the exterior.

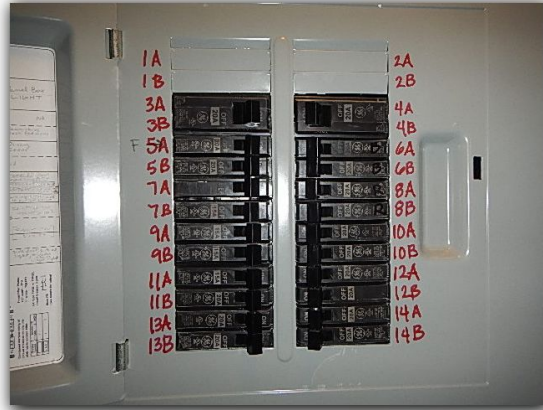
- The Sub-Panel should be able to be turned off with no more than 6 throws or movements.

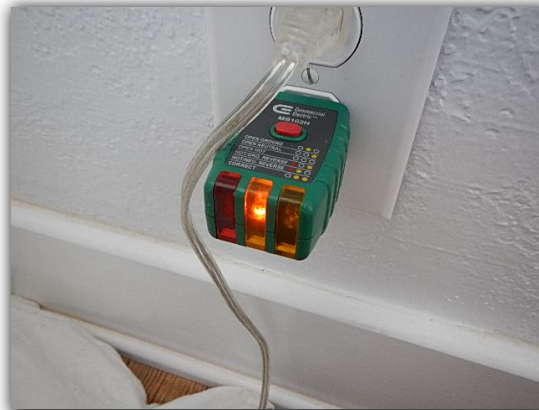
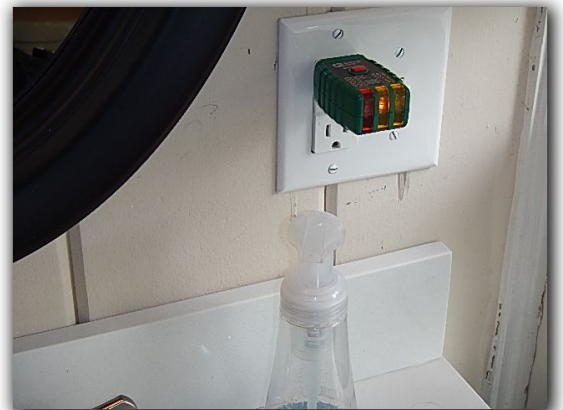
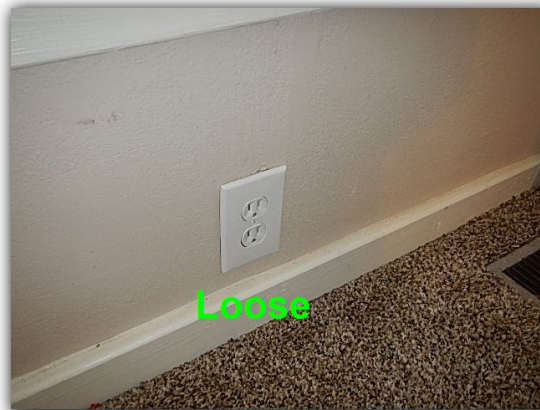
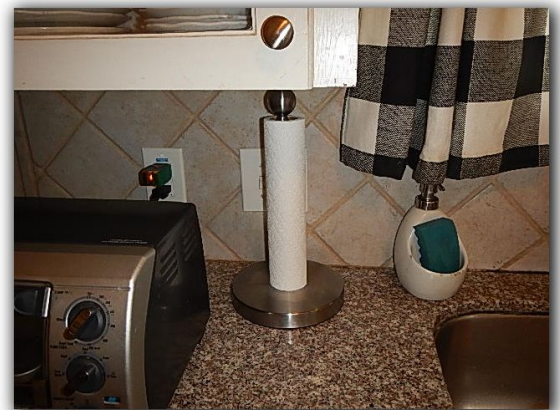
- Outlet(s) are indicating a "Bad or Open Ground". Further evaluation is recommended.
- The dryer outlet and wall switches are not grounded. This is considered normal on homes built before 1999. However, TREC requires that this be reported as deficient.
- A ground fault circuit interrupter (GFCI) outlet did not respond correctly to testing during the inspection. This receptacle should be replaced.

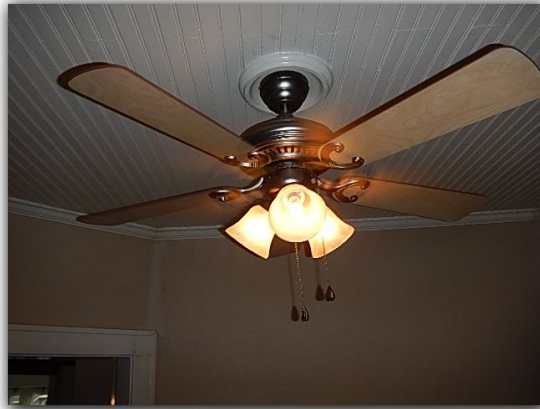
- Ceiling fan(s) are noisy and or out of balance. Balancing or replacing the ceiling fan(s) may be desirable.
- Light fixture(s) were missing a protective globe. All light fixtures within 12" of combustibles should have a globe.

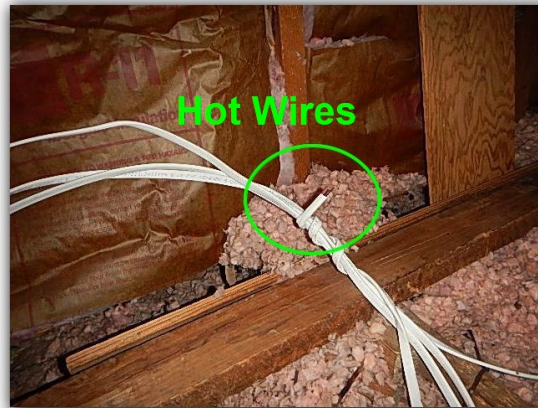
- Abandoned wiring should be replaced or appropriately terminated with wire nuts and protected in a junction box.

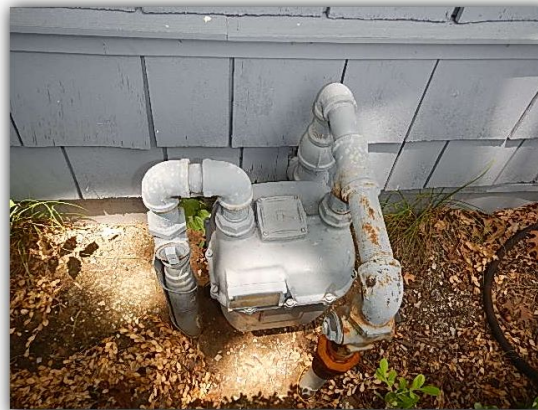
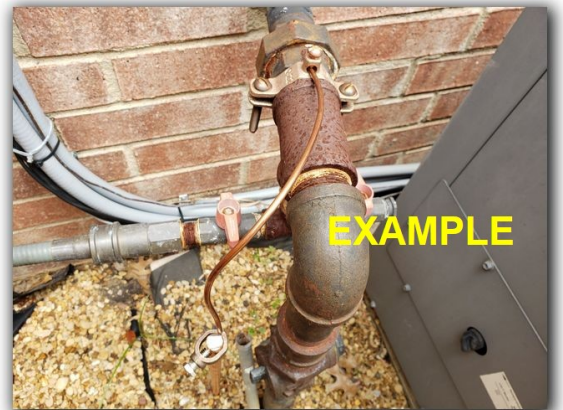
- The Gas meter or line should be grounded to the earth. (see EXAMPLE)

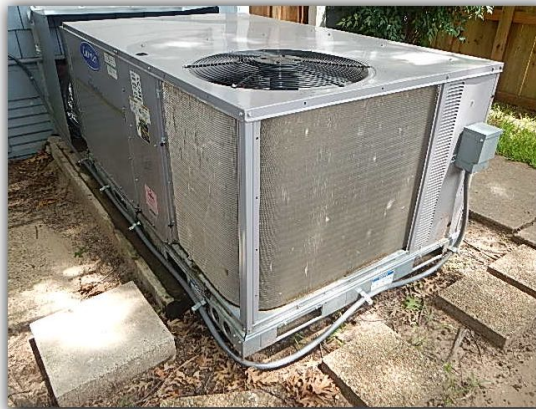
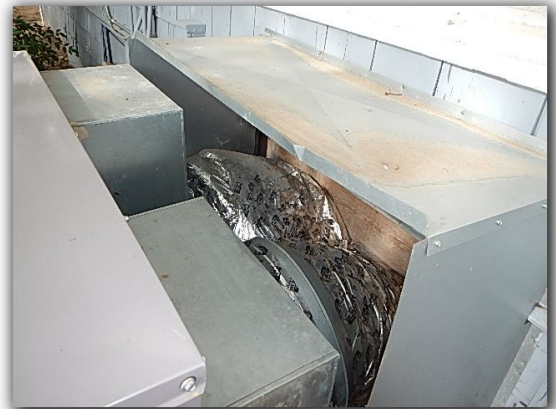
- The coil cover / louvers are missing and the supply and return ducts should be covered.

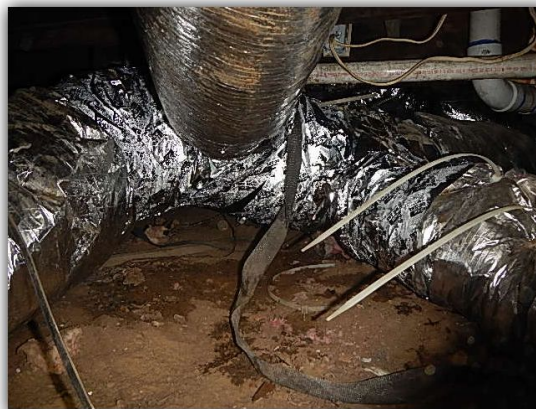
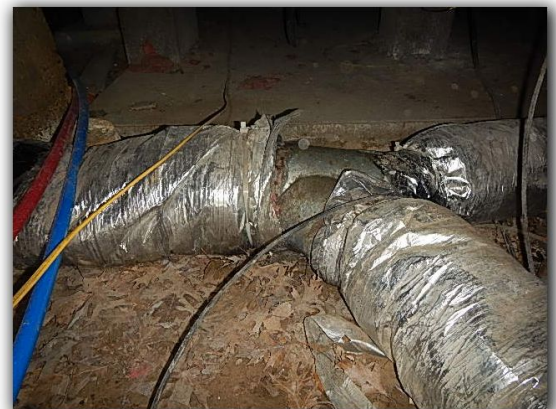
- AC vents should be suspended from the floor joists and not be positioned on the ground. A substantial amount of cold air was entering the crawlspace. This is indicative of air duct leaks. Further evaluation and repair is

recommended.

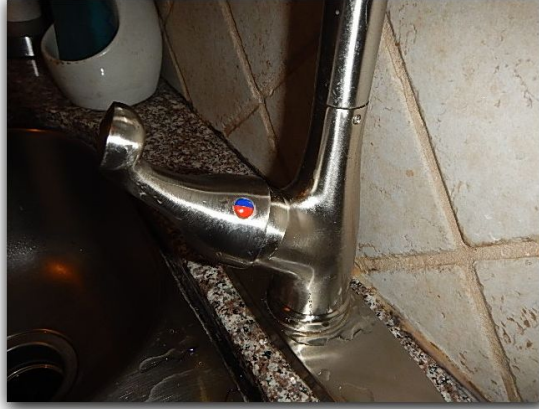
- The kitchen faucet is labeled for hot on the right and the hot is on the right. National Plumbing Code states hot should be on the left.
- Sink stopper(s) are missing or not adjusted properly. This is usually a simple repair by adjusting the stopper rod assembly underneath the faucet.

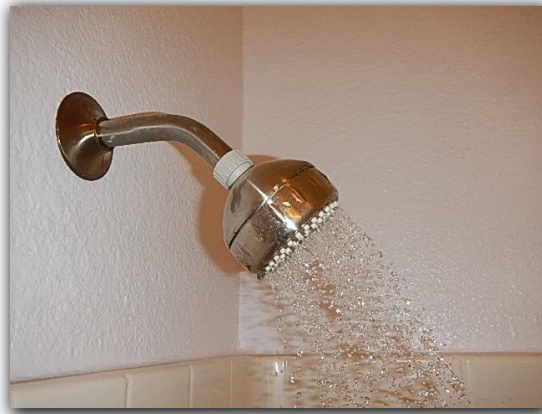
- The shower head in the down stairs bathroom has inadequate flow.

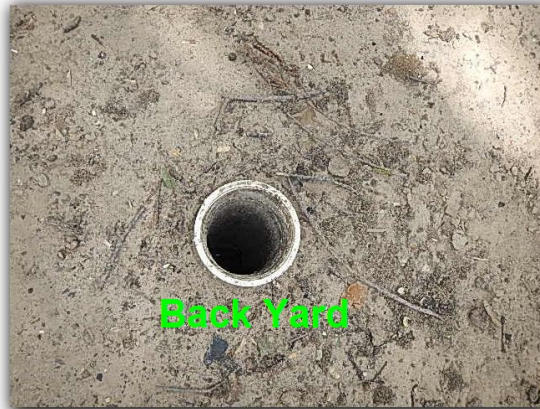
- Plumbing Clean-Out covers are damaged or missing. These should be replaced to prevent rodent, insect and reptile intrusion.

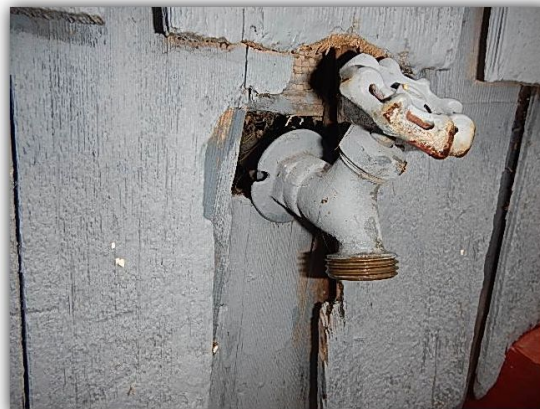
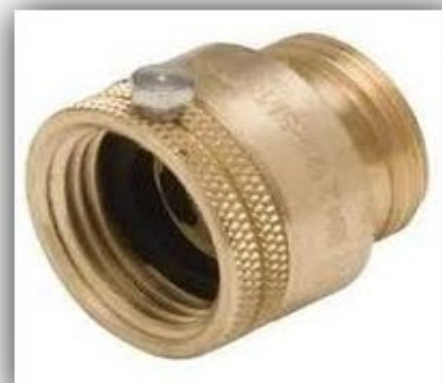
- Exterior hose bib(s) are missing anti-siphon devices.

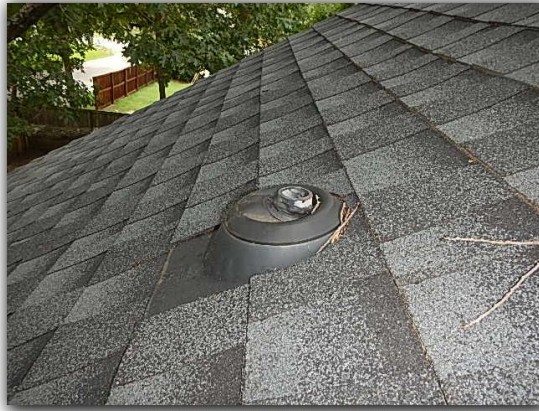
- The vent stack that penetrates the roof should extend at least 6 inches above the roof and should be at least 2 inches in diameter. Repairs should be undertaken.

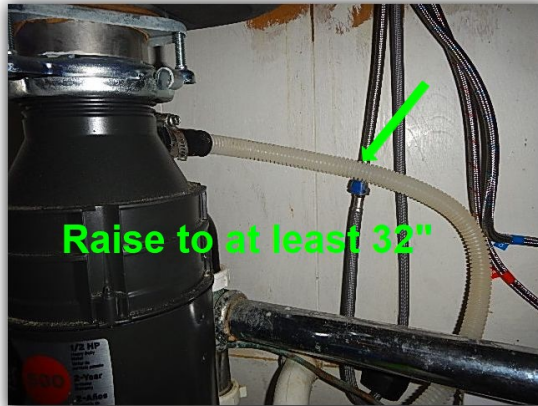
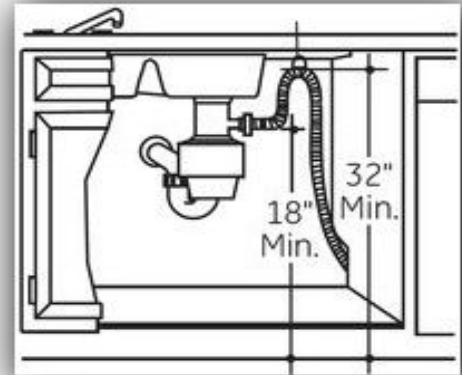
- The dishwasher drain should be elevated to at least 32" off of the floor to prevent cross-contamination (water from the disposal draining back into the dishwasher). This is recognized as a safety hazard.

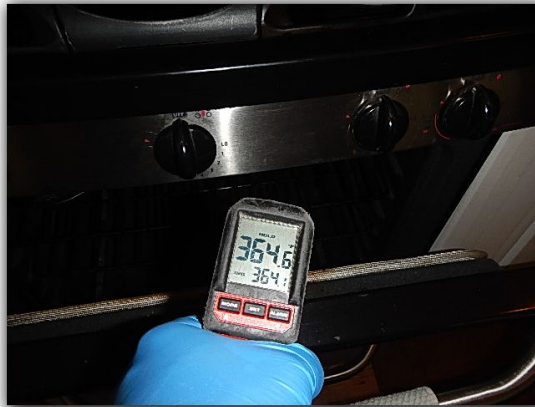
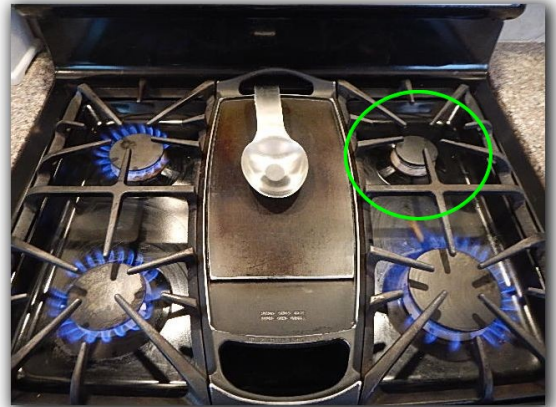
- The back left burner would not ignite.

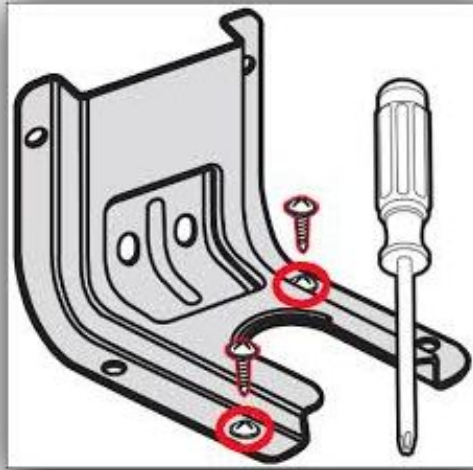
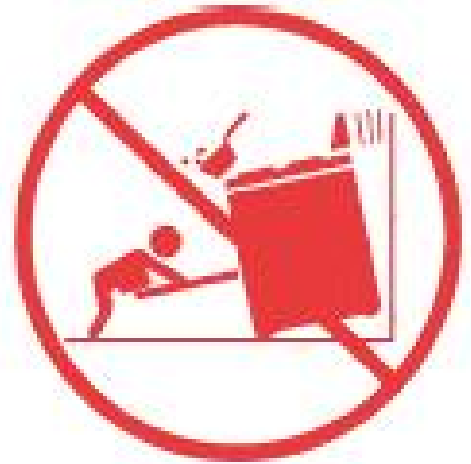
- **Anti-tip device missing from range. Anti-tip devices are simple L bracket devices that are available at any home improvement center and are inexpensive and easy to install. This is considered a safety hazard.**

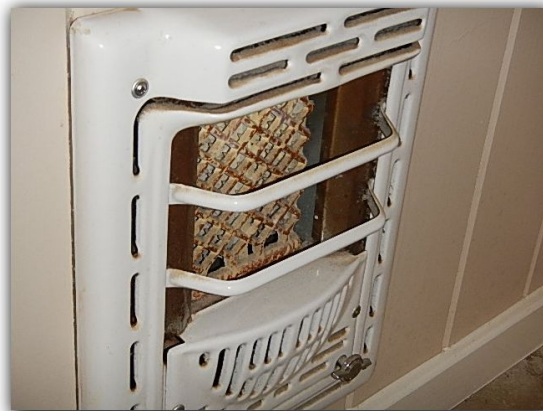
- Gas Bathroom Wall Heaters are not vented to the exterior and should not be used. This is recognized as a safety hazard.

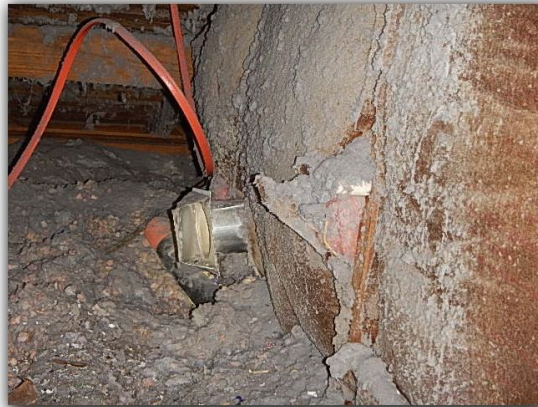
- The dryer vents into the attic. This is a considerable fire hazard and should be corrected to vent to the exterior.
