Home Inspection Report

606 W Nash St.
Terrell, TX 75106

PROPERTY INSPECTION REPORT

Prepared For: Bella and Lance Johnson
Concerning: 606 W Nash St. Terrell, TX 75106
Inspection Date: 03/24/2020

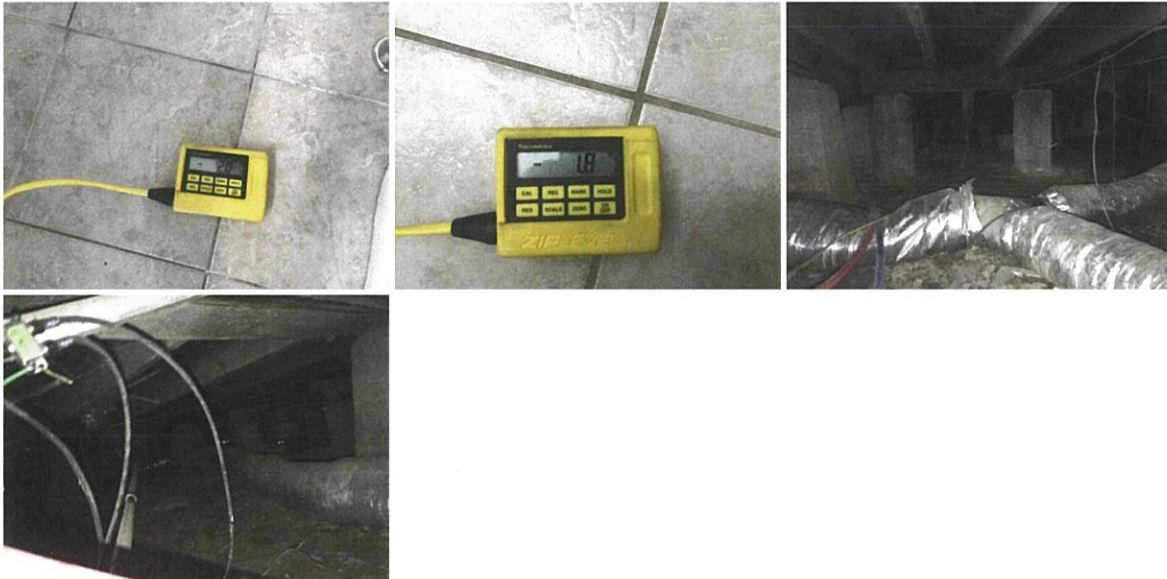
Comments: Pier and Beam Zip level readings:

Hall Bath: - 2.0" in the center of the room.

Master Bath: -1.8" in the center of the room.

*NOTE - Zip level reading of +/- 1.0" need further evaluation. There were no other signs of foundation issues in or around the house. Reading could be from the elevation difference of the flooring. Requires further evaluation.

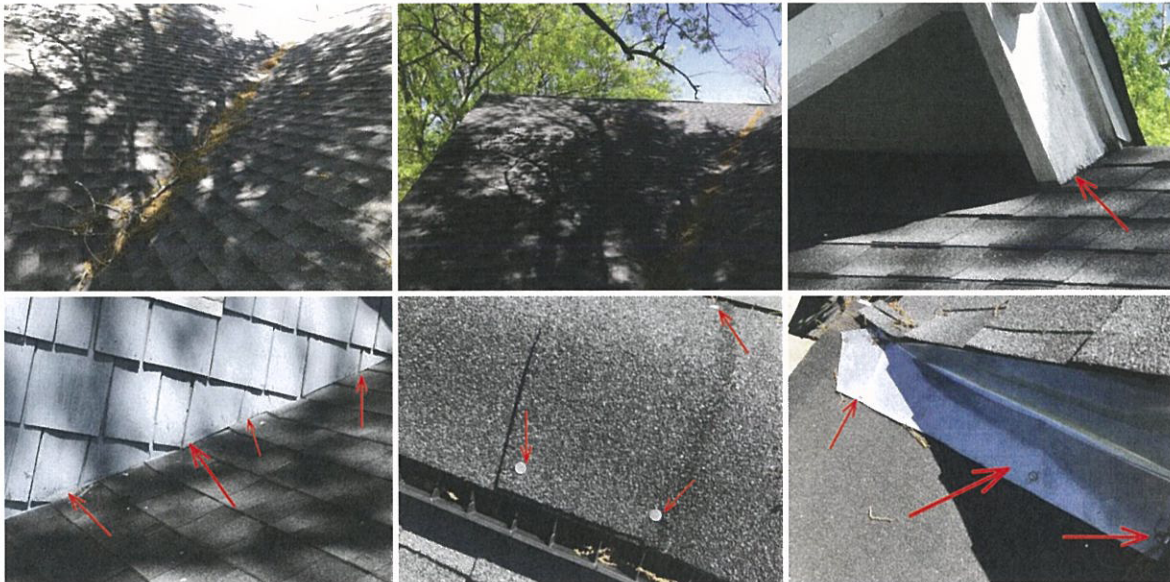
Comments: Asphalt shingle / Rolled Roofing There were nail head that were not caulked sporadically over the roof / there was a lot of debris on the roof which hold moisture on the shingles / there was wood and siding touching the shingles.

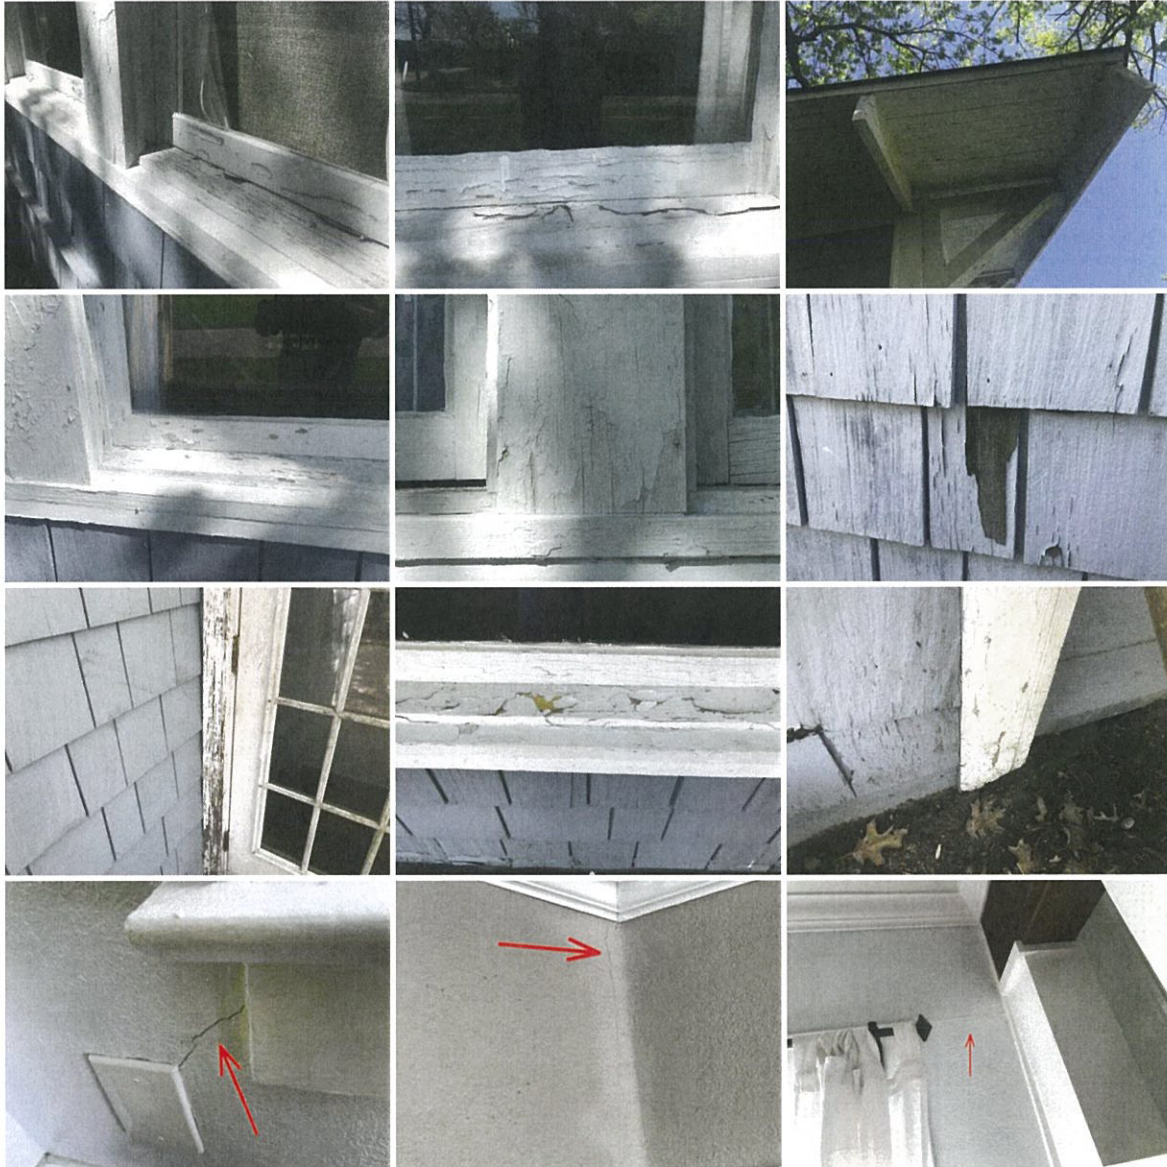
E. Walls (Interior and Exterior) - Comments: Drywall / Fibrous, Exterior:
There was peeling paint and damaged wood sporadically around the house.

There were cracks around the windows and above the doors sporadically throughout the house.

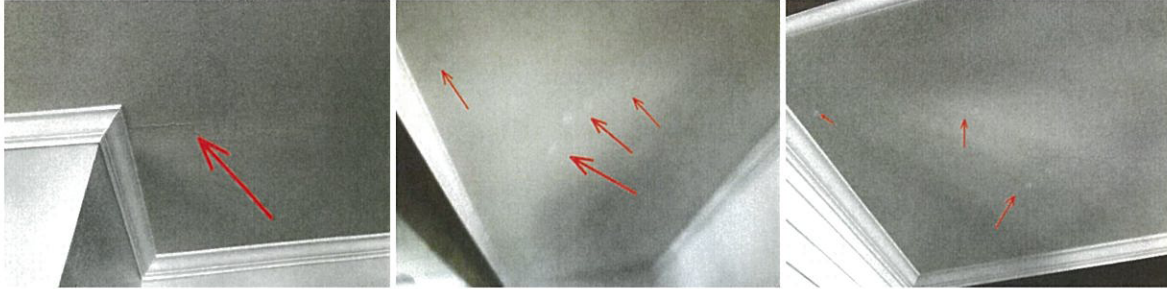
F. Ceilings and Floors - Comments: Drywall, Carpet/Tile/Wood, Master Bedroom:
There is a crack in the ceiling at the entrance.

Living Room:
There are many patches in the ceiling.

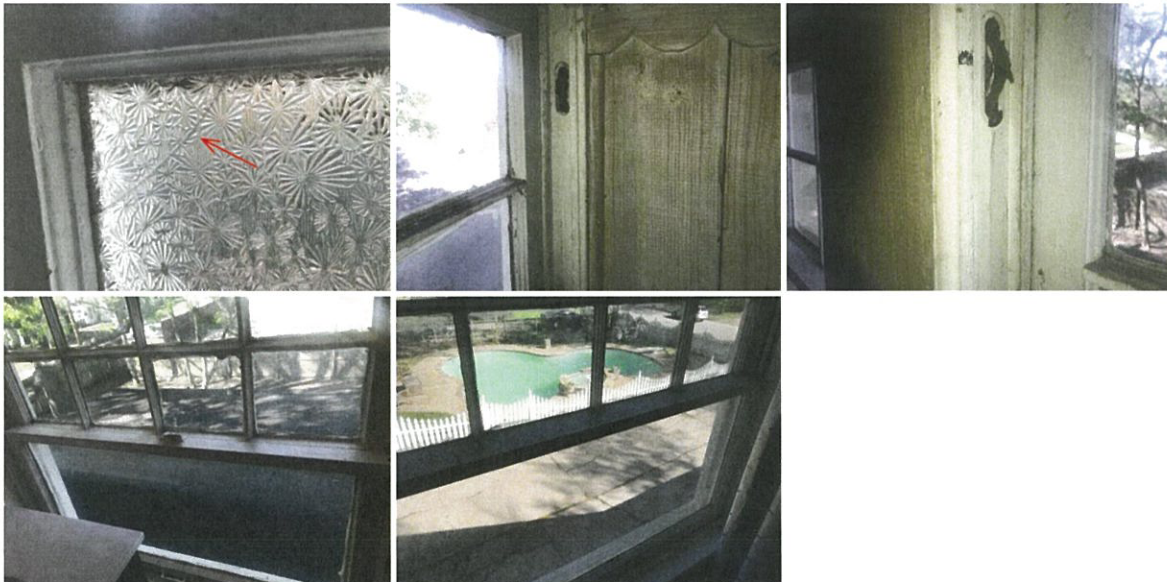
H. Windows - Comments: Wood / Metal, All the wood single pane windows are either sealed shut (safety hazard) or have missing parts. The metal windows are in working order and all window are missing the screens.

Broken window in the room by the West back door.

Broken window in the Northeast room.

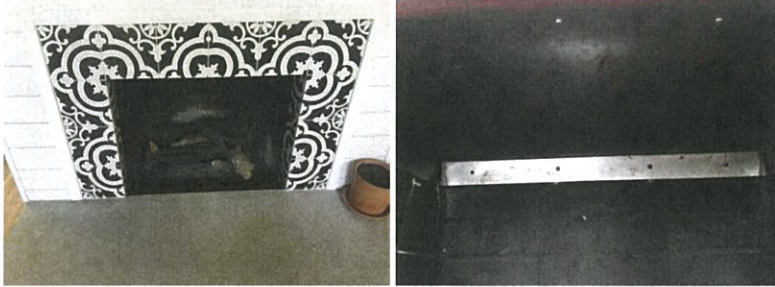
J. Fireplaces and Chimneys - Comments: ~~Decorative~~, The gas to the fireplace has been capped and the chimney has been sealed. Decorative only.

* Fireplace is not decorative... Fireplace has been completely reconstructed + is sealed because it has ventless gas logs.
The gas line just needs to be connected. ;)

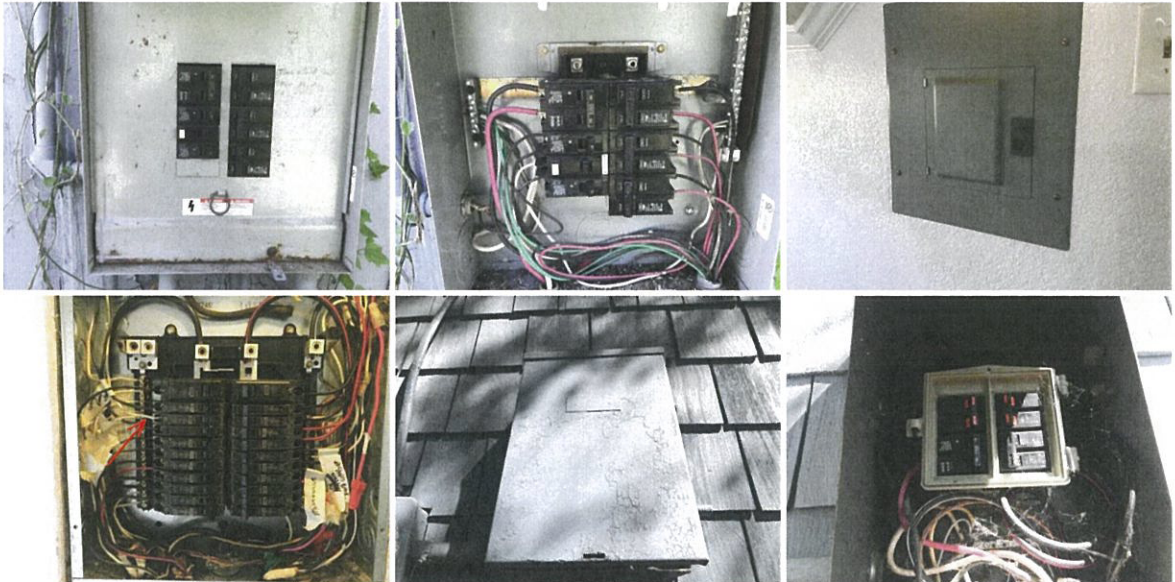
A. Service Entrance and Panels - Comments: Above Ground Service - Copper, 100 amp panel on the East side of the house. I have never seen this kind of a box inside a Federal Pacific panel before - recommend being checked out by an electrician.

G.E. box inside by the East door.
- White wires used as hot wires and not properly marked.

Unkown brand box on the West side of the Garage.

** New panel box installed... look @ electrician's email w/ notes.*

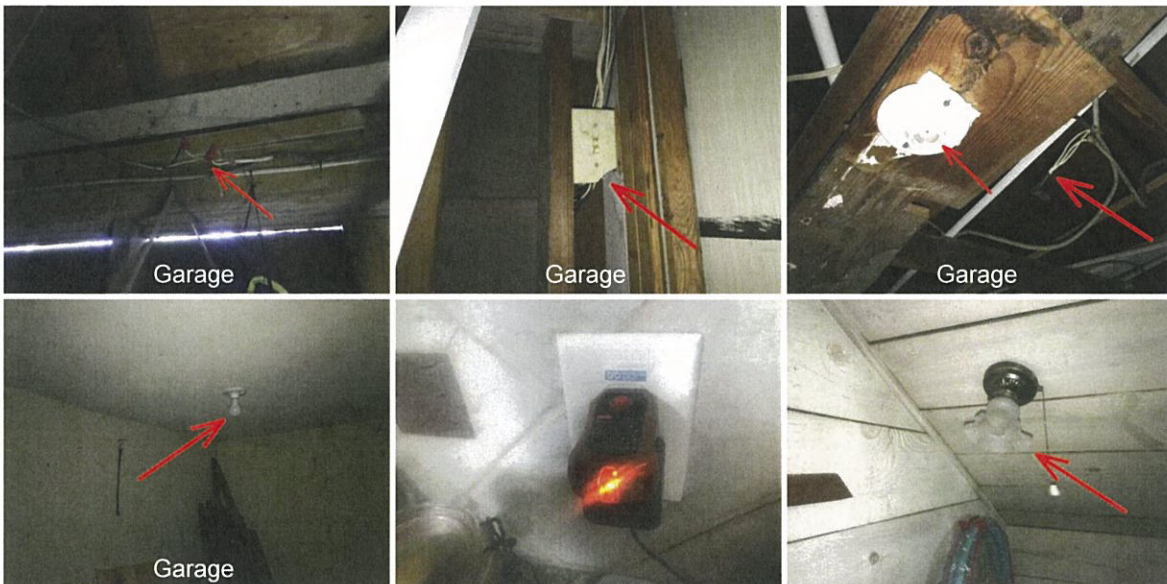
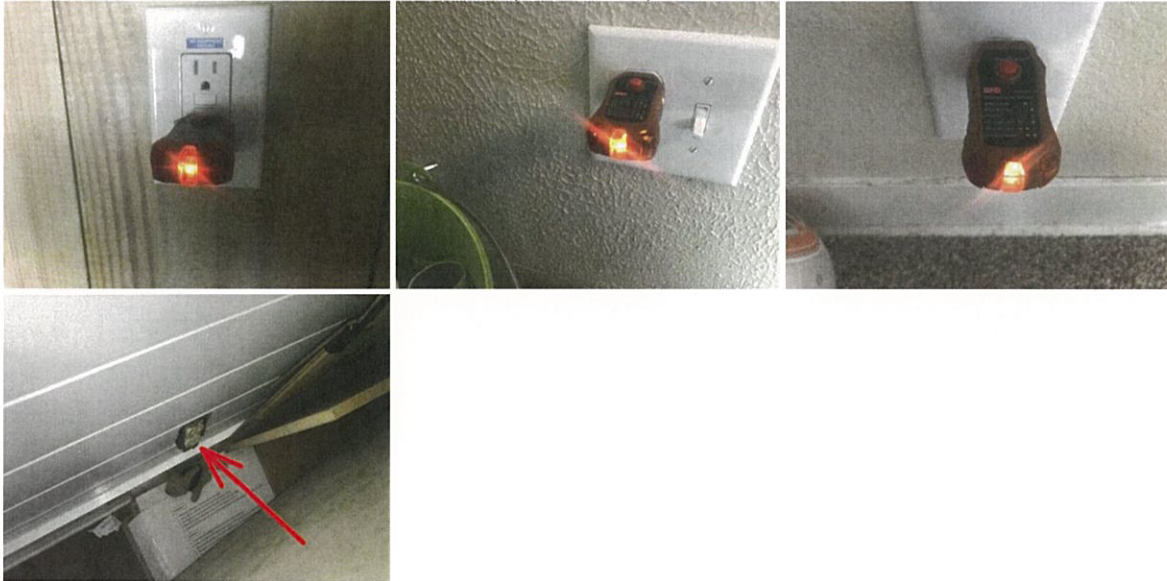
Comments: Copper Kitchen: 3 prong GFCI receptacles show not ground and do not trip with the tester / Burnt bulb above the stove*./ Burnt bulb in the hallway South of the Kitchen.

Laundry Room: Light does not turn on*.

Living Room: Loose receptacle and missing face plate behind the sofa on the North wall.

Garage: Open splices not in a junction box / non-functioning lights*.

All three prong receptacles tested showed no ground except for the one at the bottom by the refrigerator, the Northeast room and the Master Bathroom.

*replace with new bulb and consult an electrician if non-functioning.

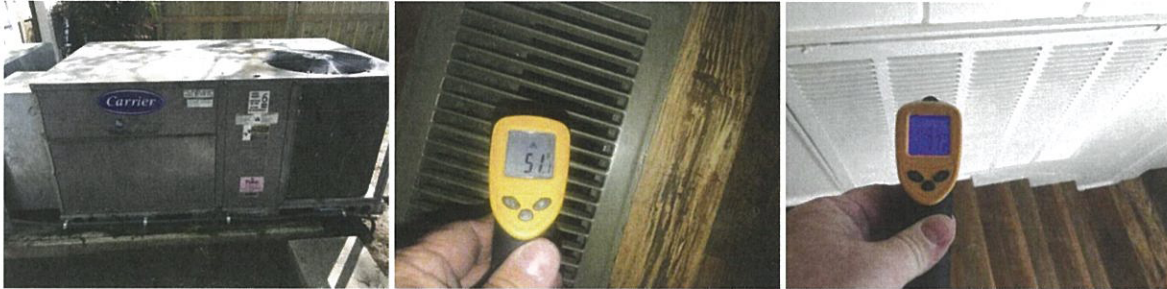
Ran the unit the entire inspection and it never cooled below 76 degrees downstairs and was noticeably hotter upstairs.

Supply = 51 degrees.

Return =77 degrees
Differential = 26 degrees

Temperature differential was Not acceptable and requires further evaluation.

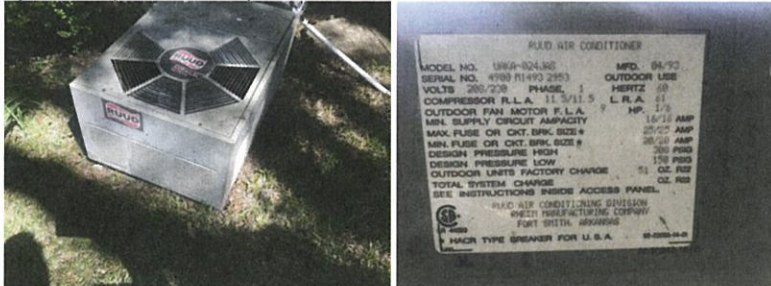
The unit is very dirty and full of debris - recommend service.

Supply = 63 degrees.
Return =80 degrees
Differential = 17 degrees

Temperature differential was acceptable.

** Unit has been cleaned
& was serviced on 6-10-20
* Changed Capacitor*

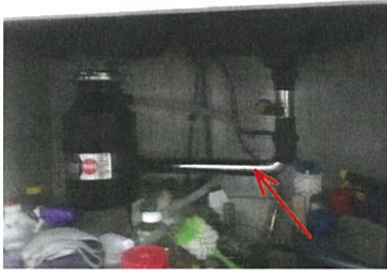
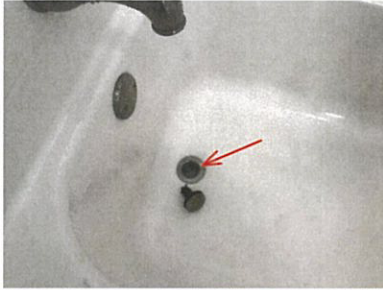
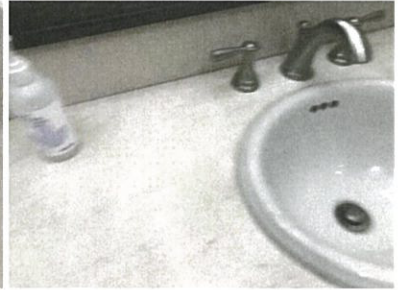
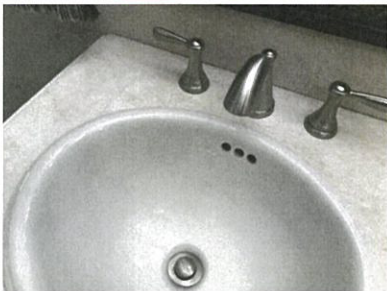
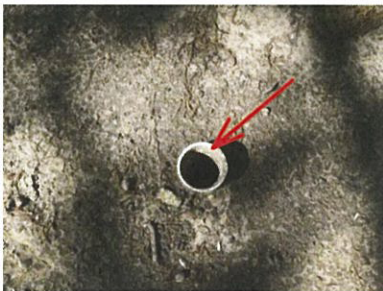
B. Drains, Wastes, and Vents - Comments: PVC / Metal / Cast Iron, Kitchen: Metal pipe needs to be replaced with PVC / There is a leak under the sink

The tub stopper is not attached.

The stoppers do not function on the sinks.

The cleanout in the back yard is missing the cap.

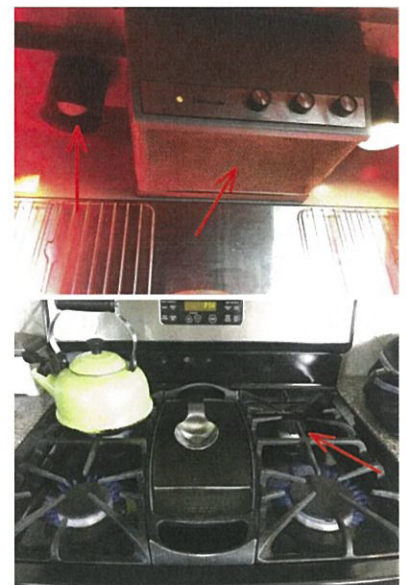
Deficient **C. Range Hood and Exhaust Systems** - Comments: Thermador, The vent fan did not work at the time of the inspection.

Deficient **D. Ranges, Cooktops, and Ovens** - Comments: Adora, The back right burner did not light at the time of the inspection.
* Burner works fine
The oven temp was within +/- 25 degrees when set at 350 degrees.

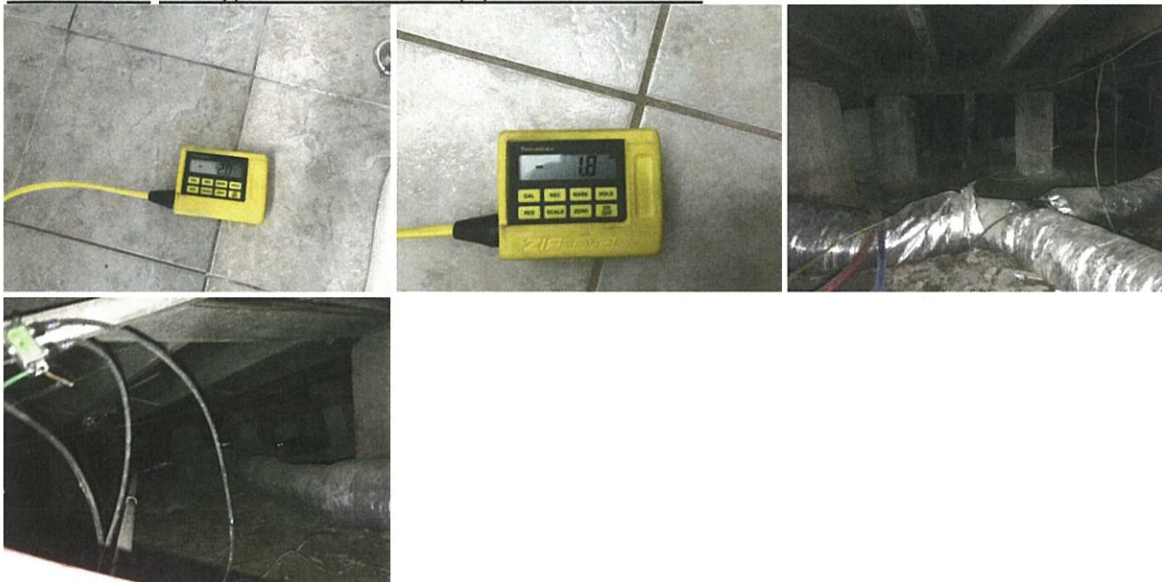
1. A. Foundations Pier and Beam, Zip level readings:
Hall Bath: - 2.0" in the center of the room.
Master Bath: -1.8" in the center of the room.

*NOTE - Zip level reading of +/- 1.0" need further evaluation. There were no other signs of foundation issues in or around the house. Reading could be from the elevation difference of the flooring. Requires further evaluation. Type of Foundation(s): Pier and Beam

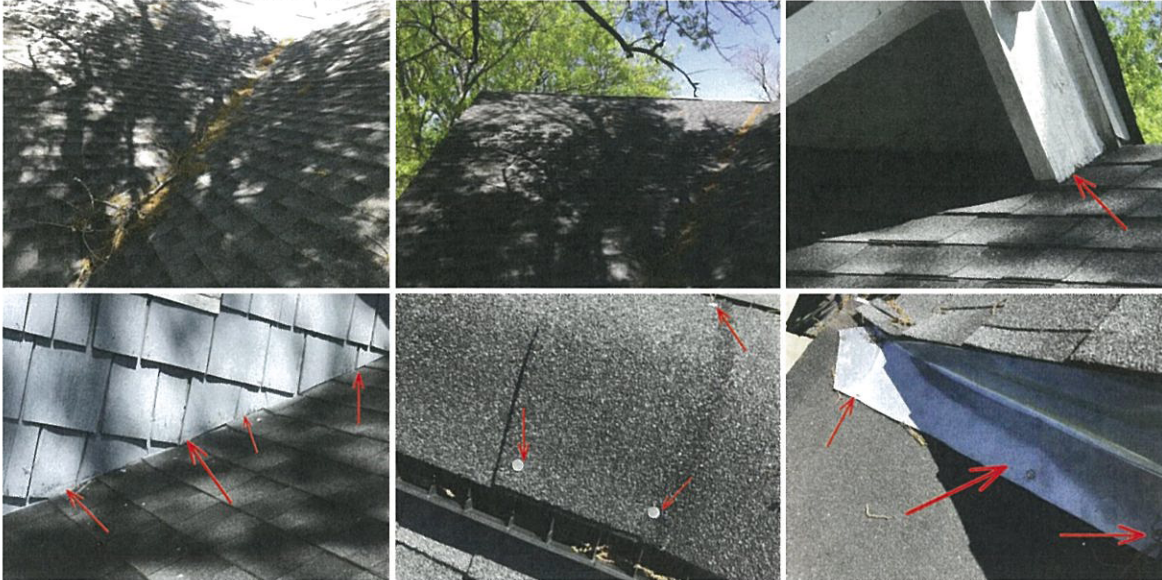
2. C. Roof Covering Materials Asphalt shingle / Rolled Roofing, There were nail head that were not caulked sporadically over the roof / there was a lot of debris on the roof which hold moister on the shingles / there was wood and siding touching the shingles.

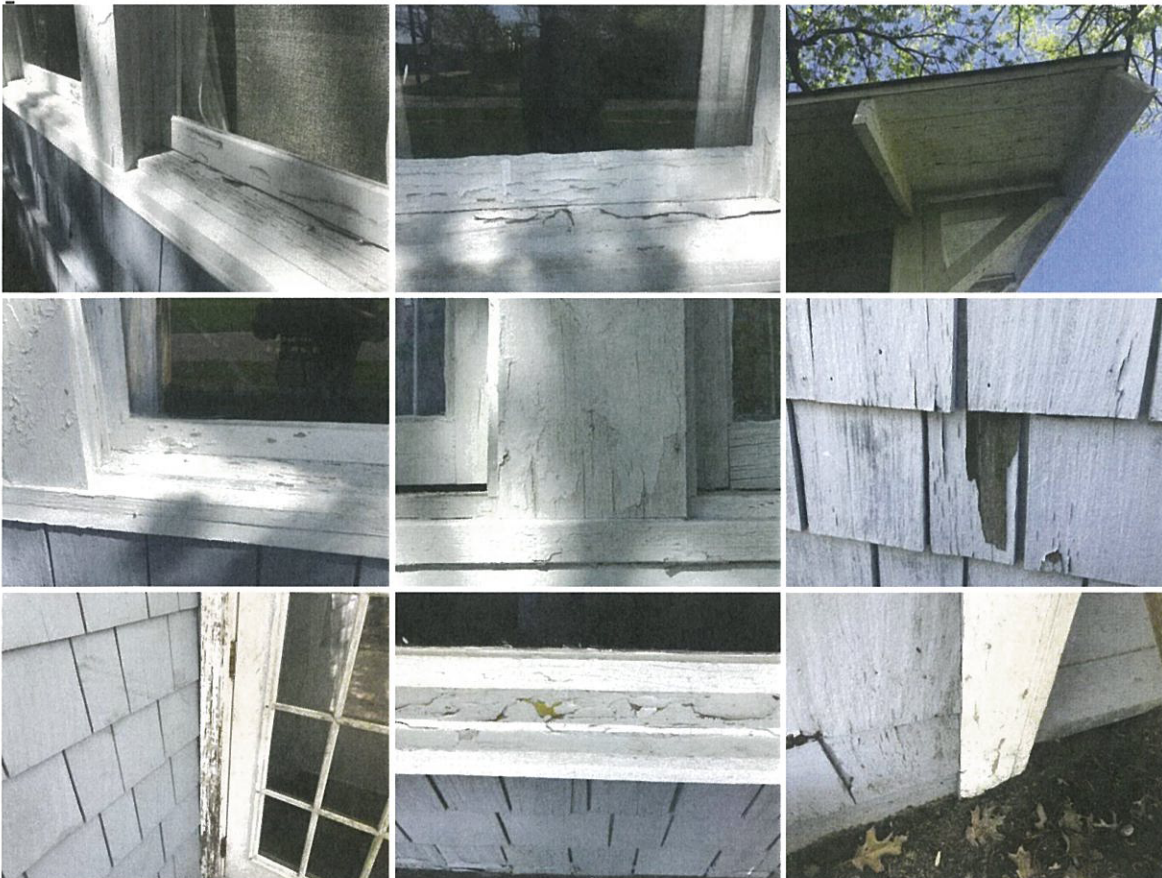
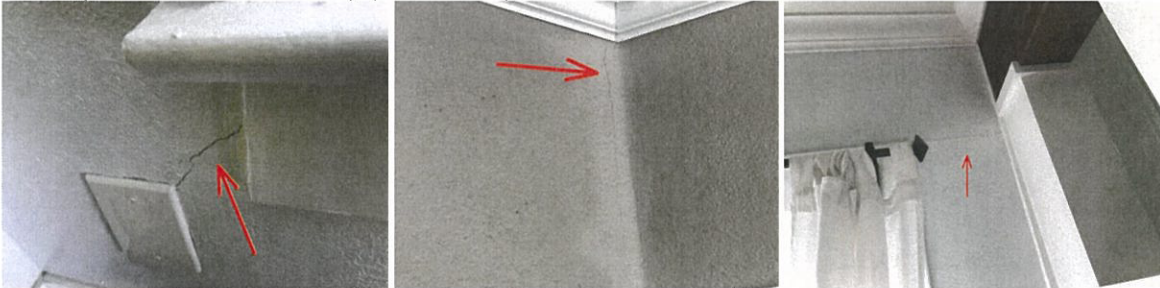
3. E. Walls (Interior and Exterior) Drywall / Fibrous, Exterior:
There was peeling paint and damaged wood sporadically around the house.

There were cracks around the windows and above the doors sporadically throughout the house.

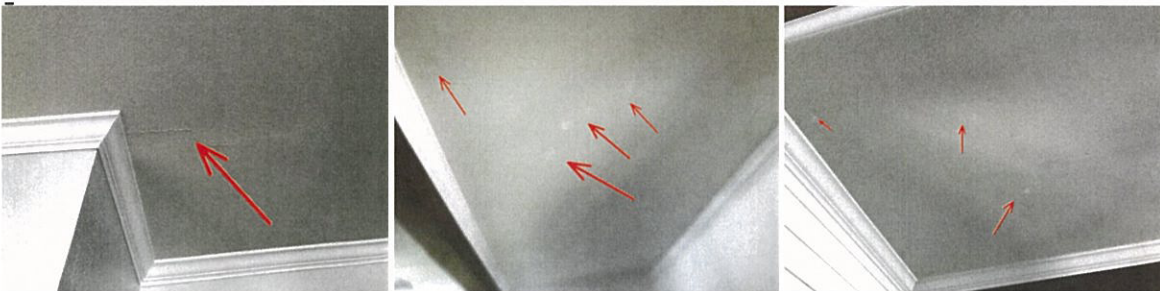
4. F. Ceilings and Floors Drywall, Carpet/Tile/Wood, Master Bedroom:
There is a crack in the ceiling at the entrance.

There are many patches in the ceiling.

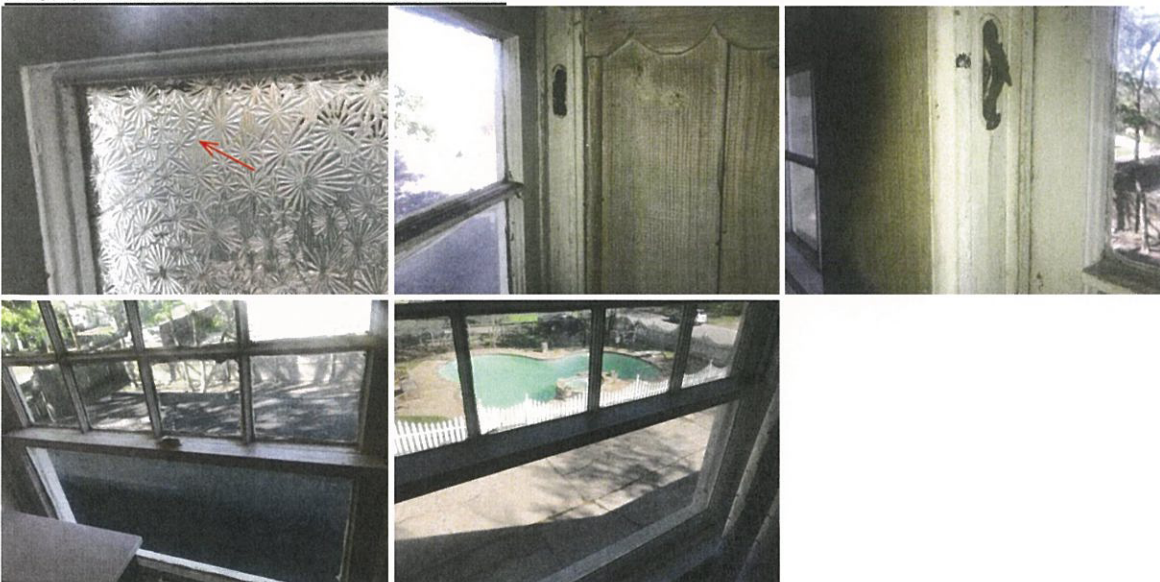
5. H. Windows Wood / Metal, All the wood single pane windows are either sealed shut (safety hazard) or have missing parts. The metal windows are in working order and all window are missing the screens.

Broken window in the room by the West back door.

Broken window in the Northeast room.

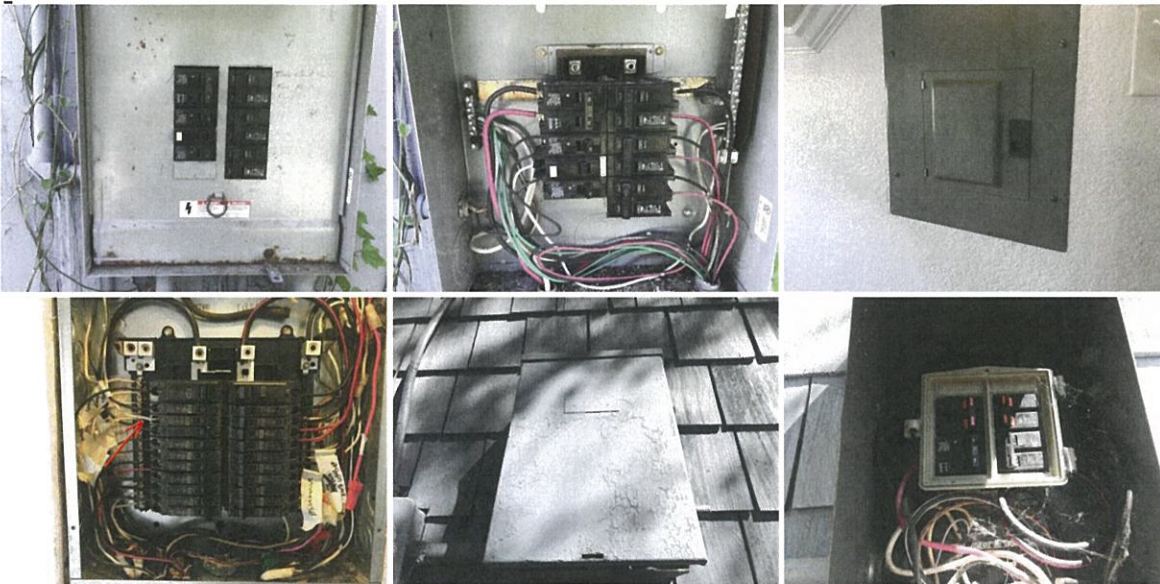
6. A. Service Entrance and Panels Above Ground Service - Copper, 100 amp panel on the East side of the house. I have never seen this kind of a box inside a Federal Pacific panel before - recommend being checked out by an electrician.

G.E. box inside by the East door.

- White wires used as hot wires and not properly marked.

Unkown brand box on the West side of the Garage.

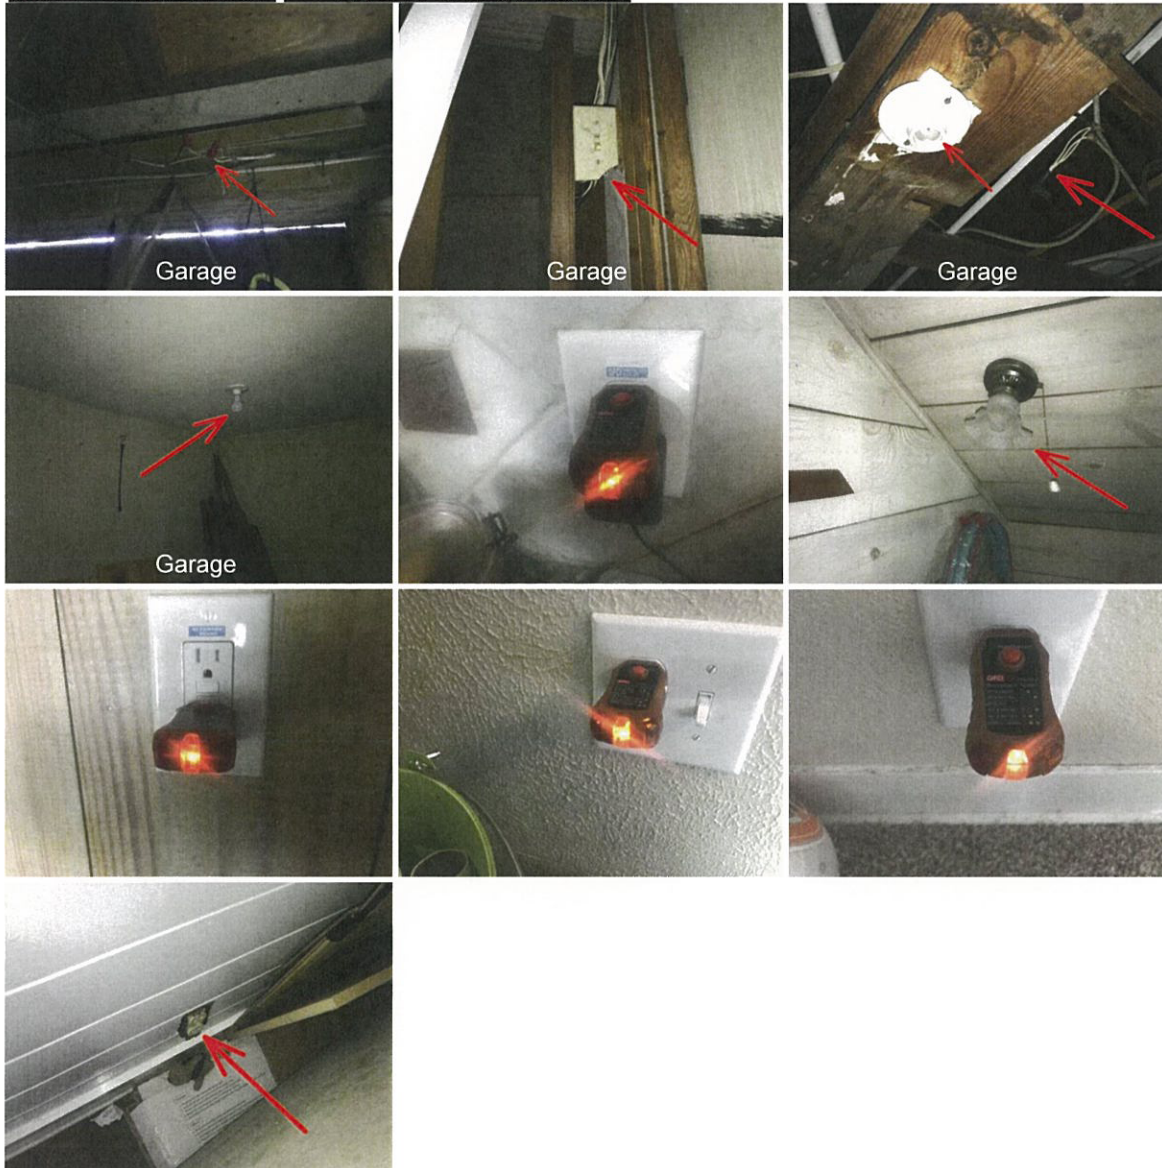
7. B. Branch Circuits, Connected Devices, and Fixtures Copper, Kitchen: 3 prong GFCI receptacles show not ground and do not trip with the tester / Burnt bulb above the stove*./ Burnt bulb in the hallway South of the Kitchen.

Laundry Room: Light does not turn on*.

Living Room: Loose receptacle and missing face plate behind the sofa on the North wall.

Garage: Open splices not in a junction box / non-functioning lights*.

All three prong receptacles tested showed no ground except for the one at the bottom by the refrigerator, the Northeast room and the Master Bathroom.

*replace with new bulb and consult an electrician if non-functioning.

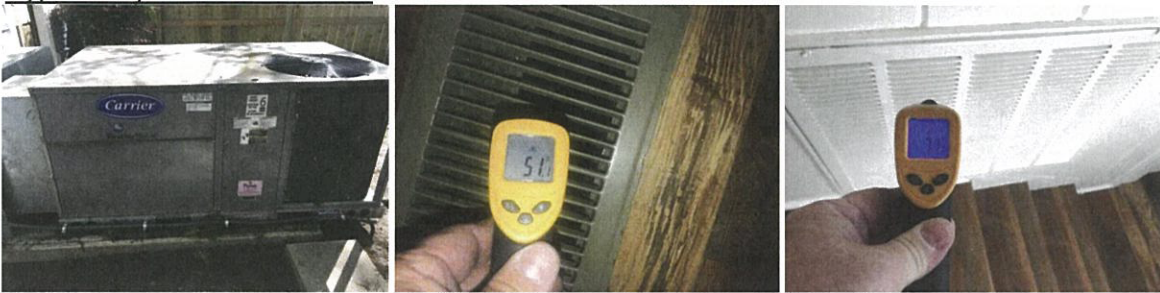
Ran the unit the entire inspection and it never cooled below 76 degrees downstairs and was noticeably hotter upstairs.

Supply = 51 degrees.

Return = 77 degrees

Differential = 26 degrees

Temperature differential was Not acceptable and requires further evaluation.

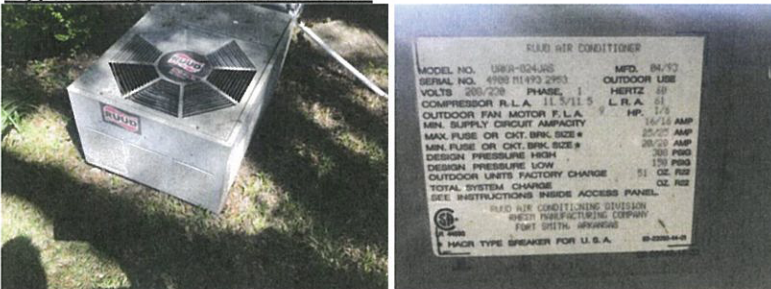
The unit is very dirty and full of debris - recommend service.

Supply = 63 degrees.

Return = 80 degrees

Differential = 17 degrees

Temperature differential was acceptable.

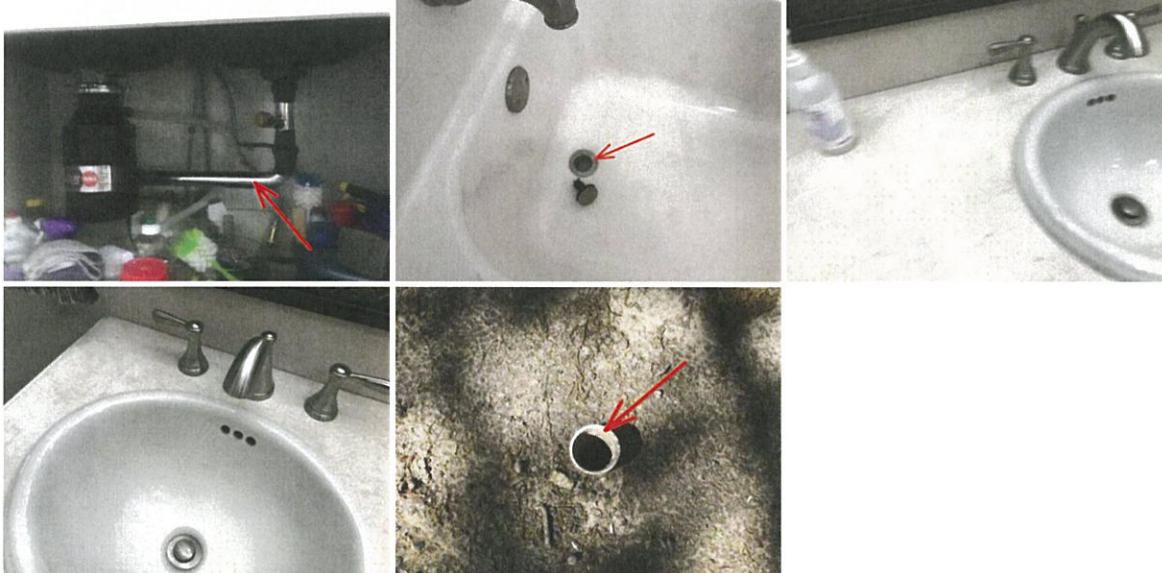
10. B. Drains, Wastes, and Vents PVC / Metal / Cast Iron, Kitchen:
Metal pipe needs to be replaced with PVC / There is a leak under the sink

The cleanout in the back yard is missing the cap.

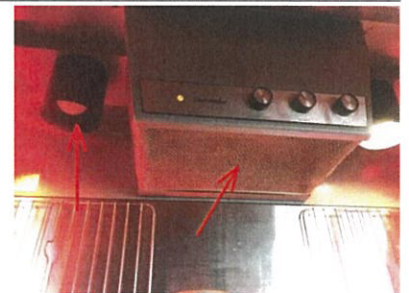
11. C. Range Hood and Exhaust Systems Thermador, The vent fan did not work at the time of the inspection.

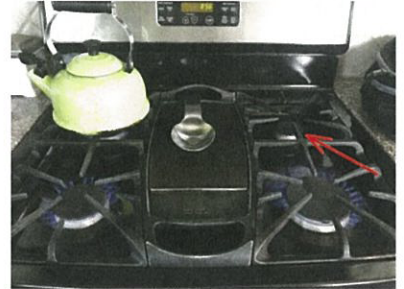
12. D. Ranges, Cooktops, and Ovens Adora. The back right burner did not light at the time of the inspection.

The oven temp was within +/- 25 degrees when set at 350 degrees.

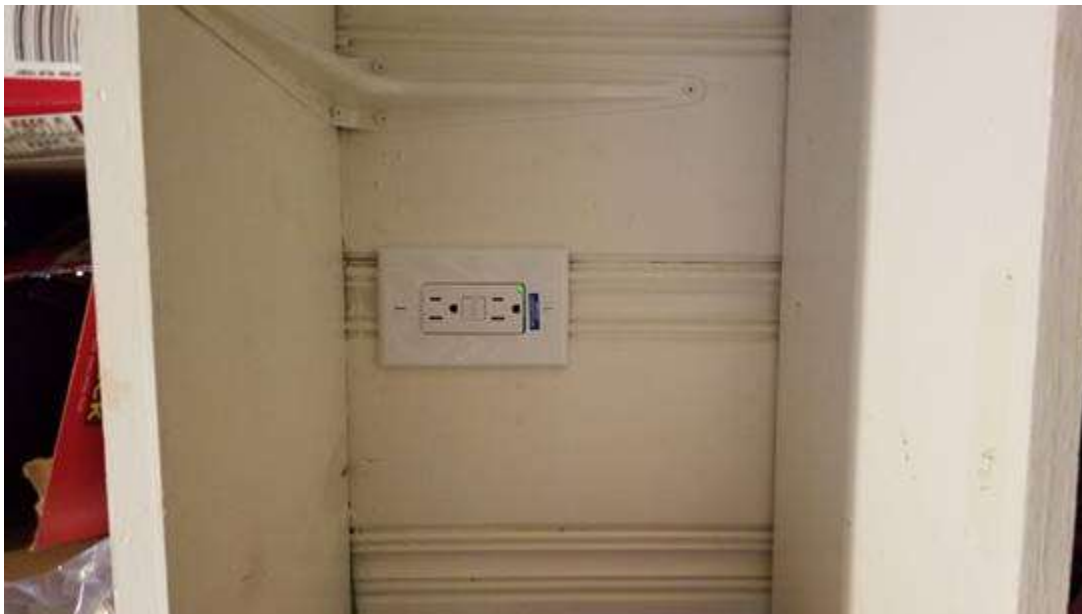
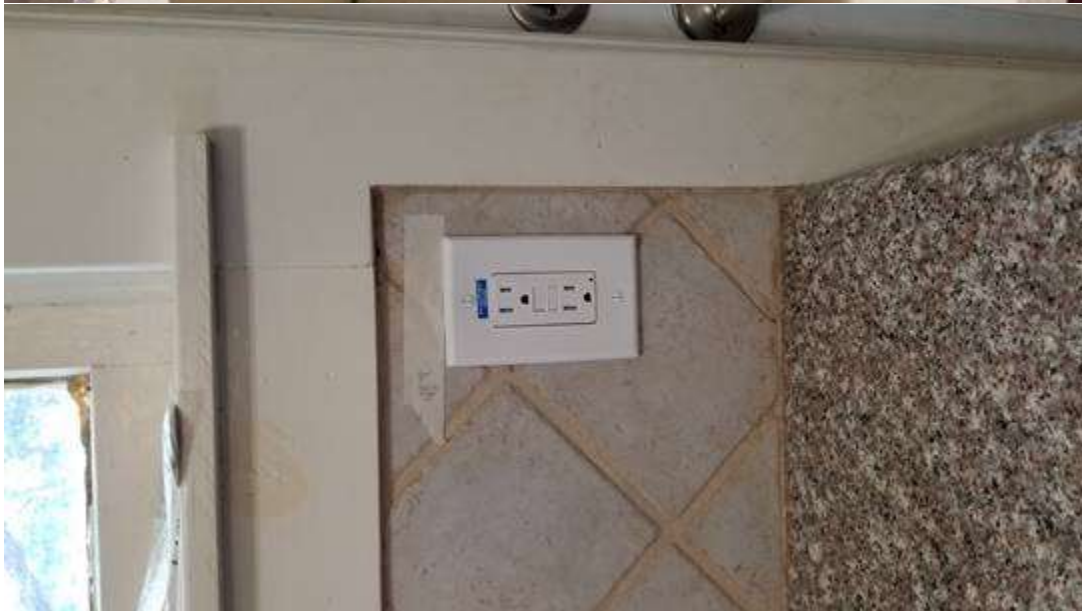
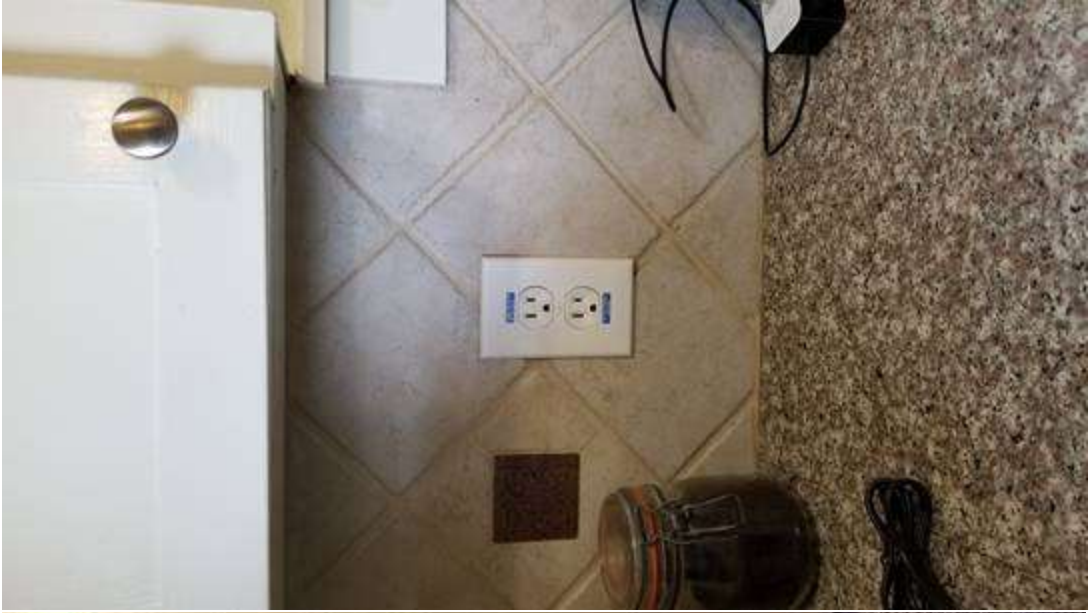
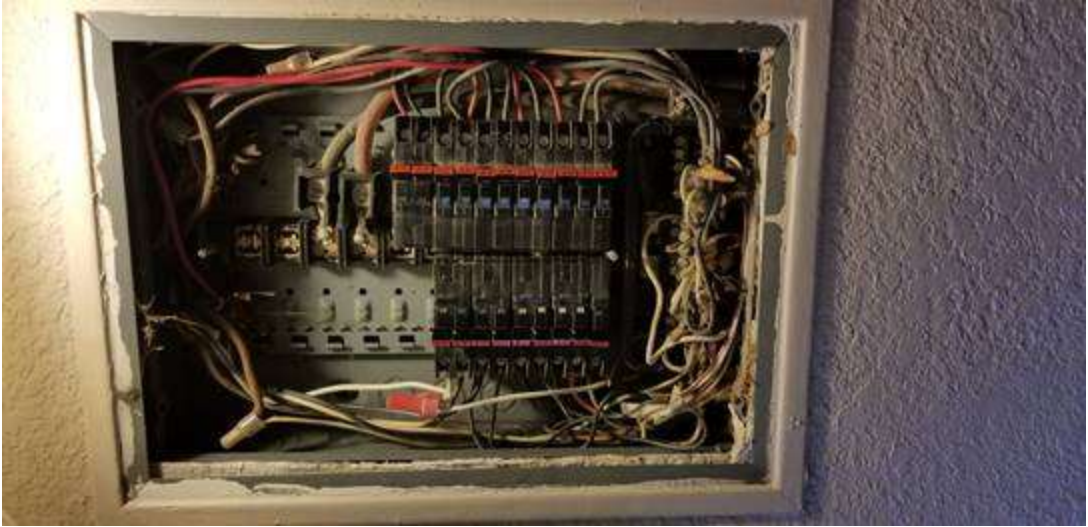
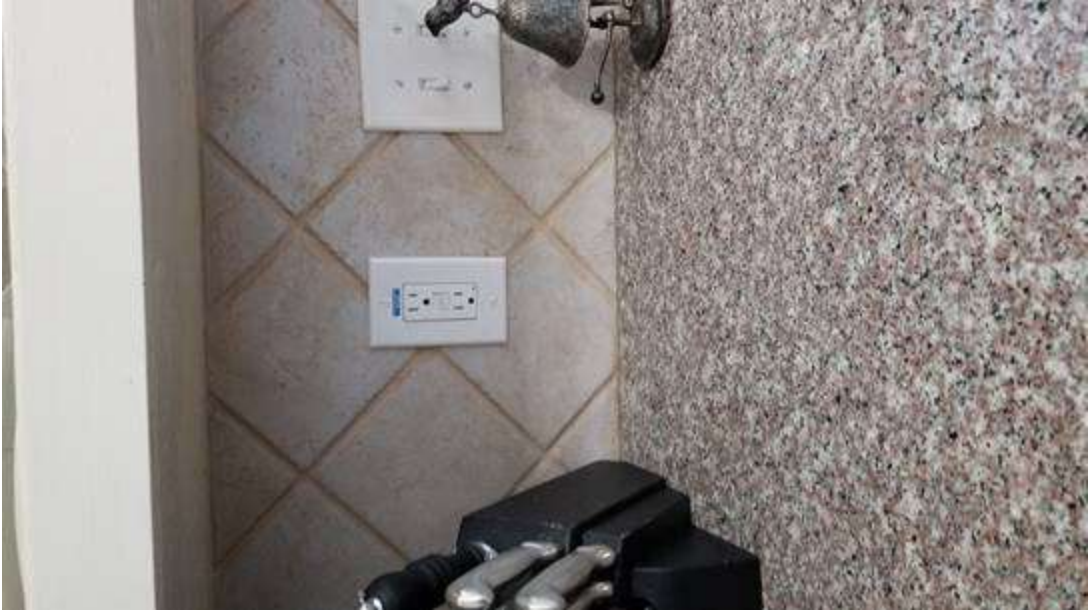
I have attached pictures and PDF's of the work that we did concerning the panel and the GFCI's in the kitchen. Notice in the picture that the outlets are labeled "no equipment ground."

One of the methods permitted in 406.4(D)(2) is to replace a non-grounding type receptacle with a GFCI type receptacle.

*(b) A non–grounding-type receptacle(s) shall be permitted to be replaced with a **ground-fault circuit interrupter-type of receptacle(s)**. These receptacles **or their cover plates** shall be marked "**No Equipment Ground.**" An equipment grounding conductor shall not be connected from the ground-fault circuit-interrupter-type receptacle to any outlet supplied from the ground-fault circuit-interrupter receptacle.*
