Expert Home Inspections

PROPERTY INSPECTION REPORT

Concerning: 606 W Nash Street, Terrell, TX 75160
(Address or Other Identification of Inspected Property)

By: Mark Serrioz, Lic #20867 07/10/2020
(Name and License Number of Inspector) (Date)

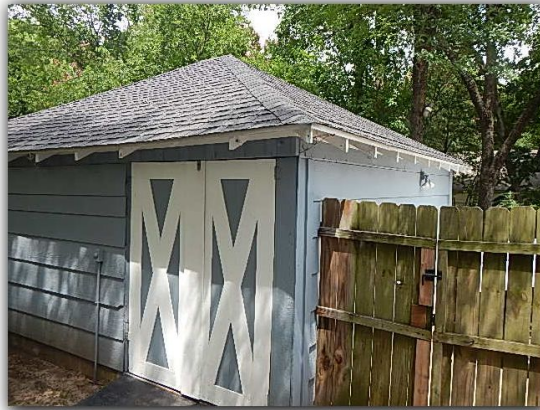
L. Other

- Added structures such as detached garages, patio covers, porches, decks, carports, pergolas, out-buildings, storage buildings, storage sheds, barns and pool houses are not included in a general home inspection.

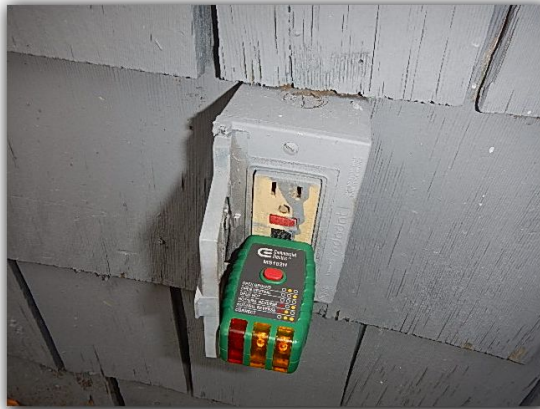
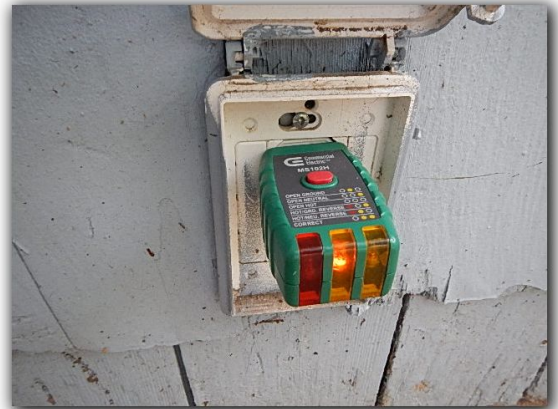
Outlet and Switches

Comments: Home was occupied at time of inspection. Most outlets were blocked or obscured by, wall treatments, heavy, fragile, and stored items. The majority of outlets could not be tested or inspected closely.
