Home Inspection Report

606 W Nash St.
Terrell, TX 75106

PROPERTY INSPECTION REPORT

Prepared For: Bella and Lance Johnson
Concerning: 606 W Nash St. Terrell, TX 75106
Inspection Date: 03/24/2020

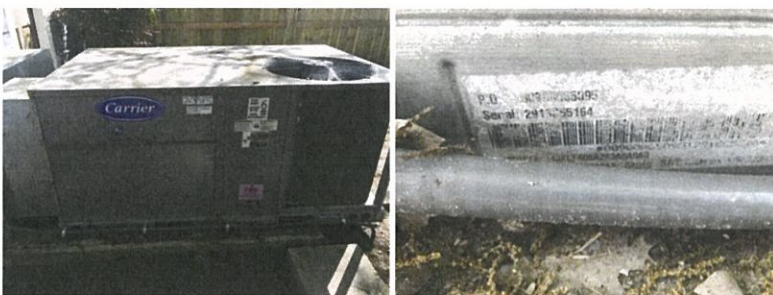
Type of Systems: Forced Air
Energy Sources: Natural Gas
Comments: Carrier Furnace

*NOTE: Due to the ambient outside temperature being over 60 degrees, the furnace was not tested.

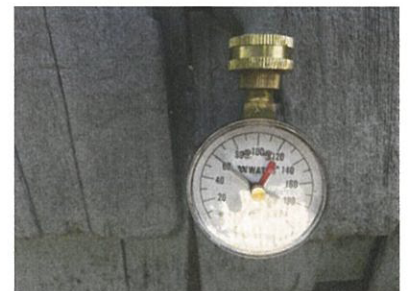
Static water pressure reading: approximately 60 psi at the front hose bib

Comments: Copper / Pex / metal *Note - Static water pressure should fall between 40 PSI and 80 PSI. Any reading outside this parameter requires further evaluation.

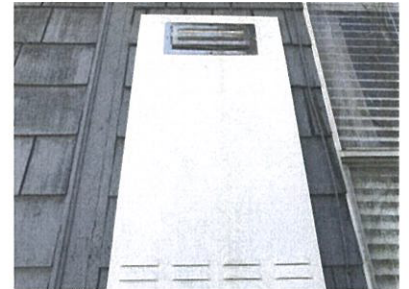
Comments: Bosch The water heating equipment appears to be functioning as intended at the time of this inspection.

Could not get the cover off to see the data plate.
